City of New Haven Long Term CSO Control Plan

New Haven Water Pollution Control Authority

Technical Memorandum #5 Monitoring Program Results

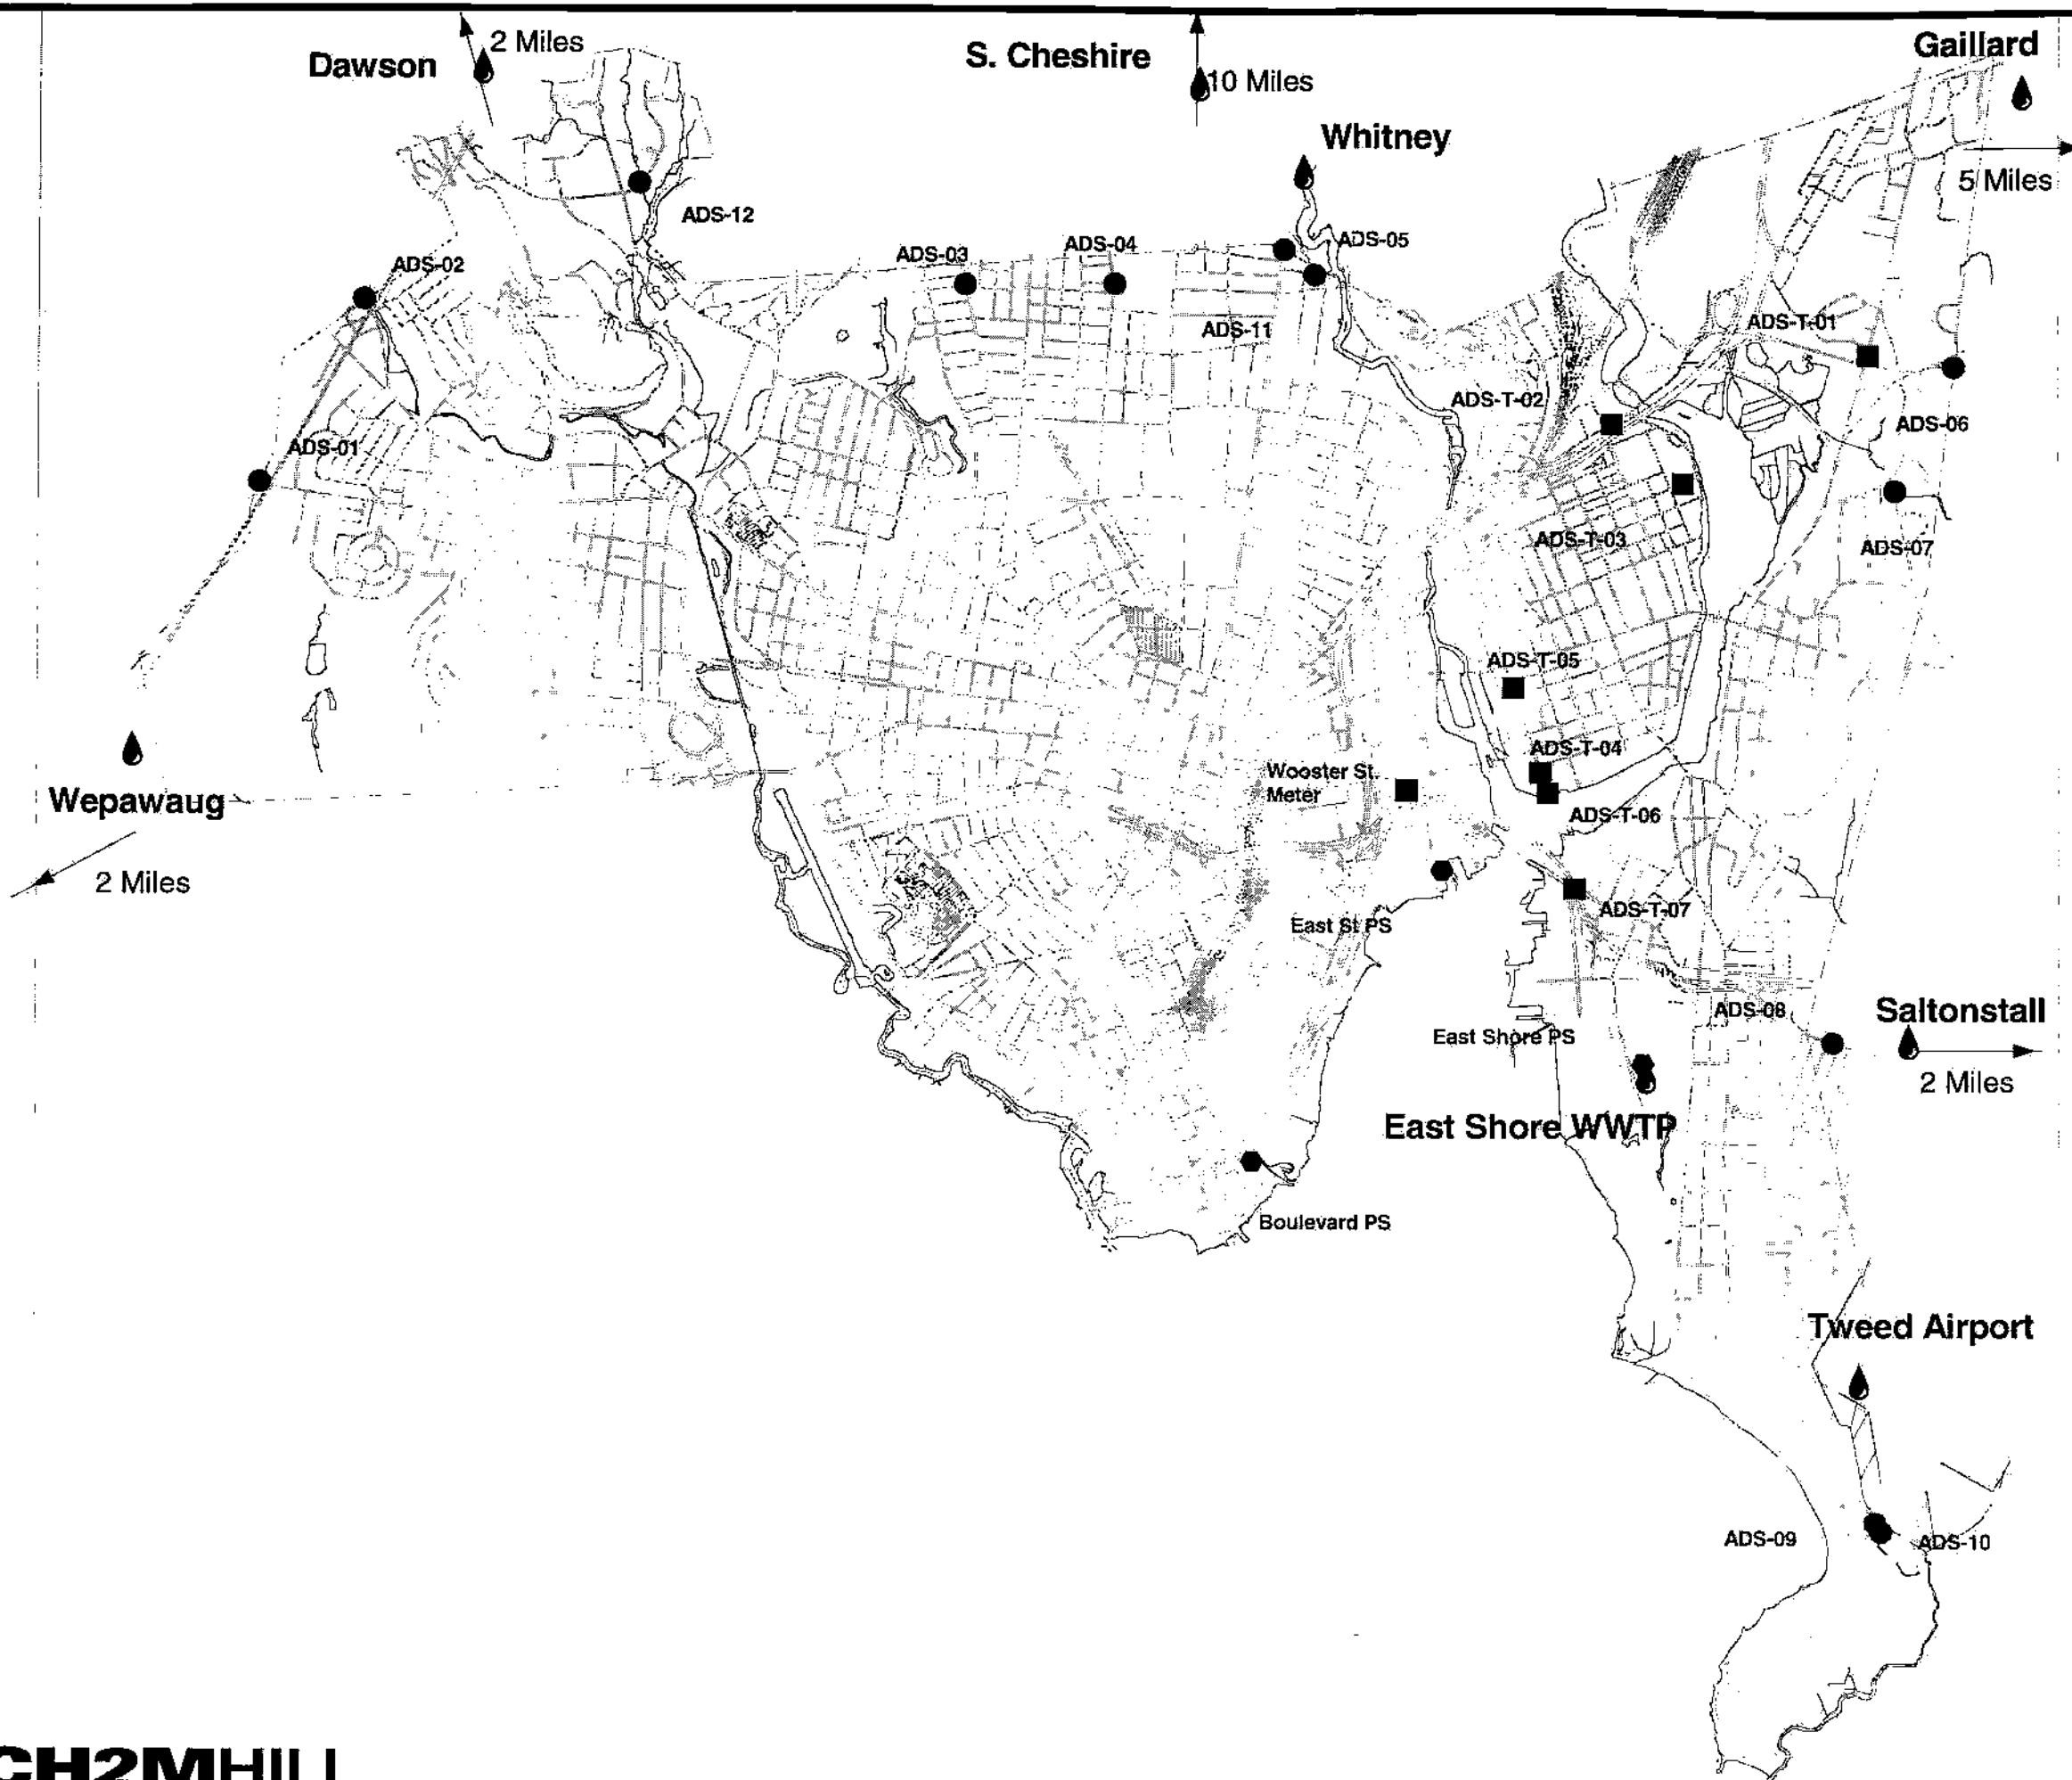
Figure 1 shows a map identifying the gauges that are listed above, with the exception of the rain gauge in Hartford. Figure 2 is a chart which provides the duration of records for the various data sets.

- Legend:**
- Rain Gauges
 - Flow Monitors
 - ADS External
 - Fair Haven Temporary
 - Pump Stations
 - Wooster Meter
 - Water Bodies
 - City Limits

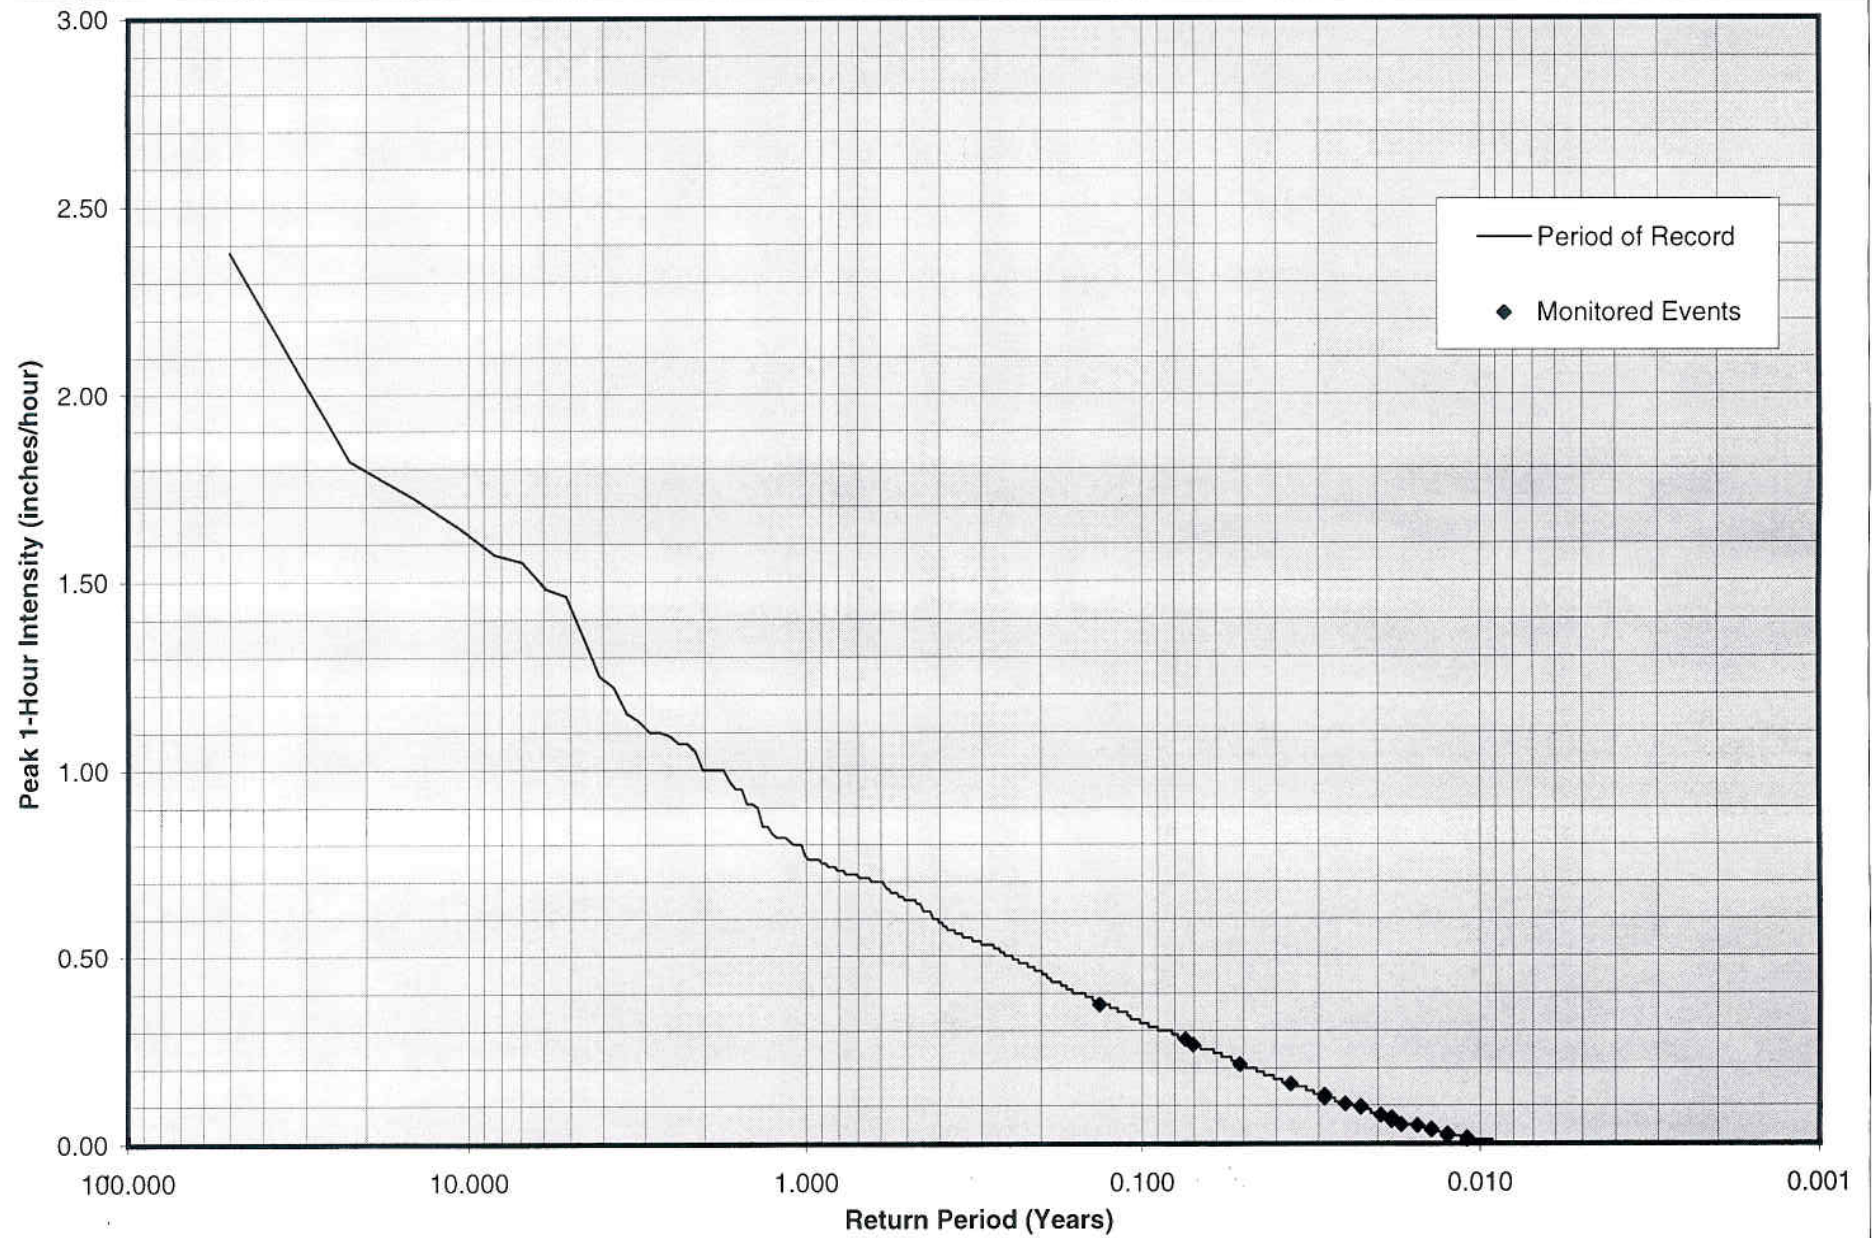
Figure 8

Precipitation Intensity Return Periods

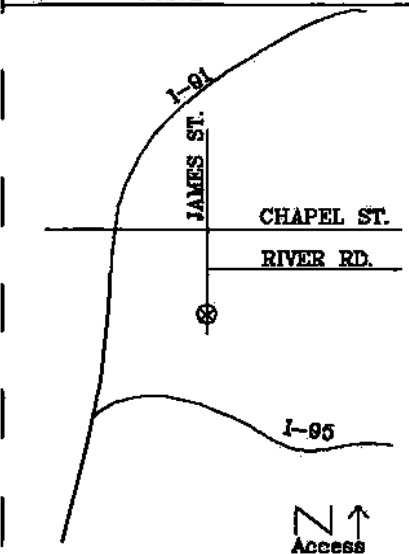
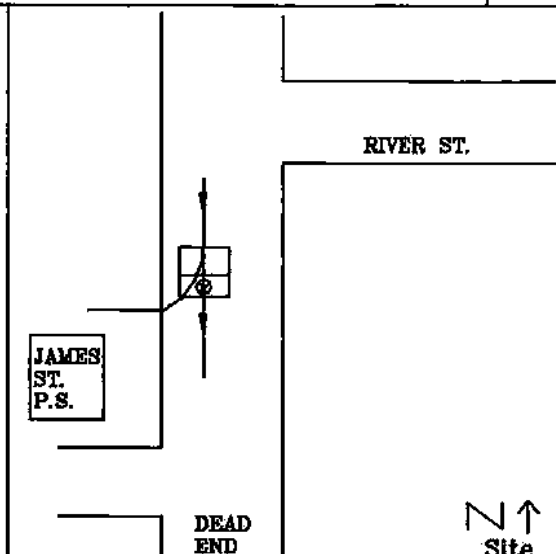
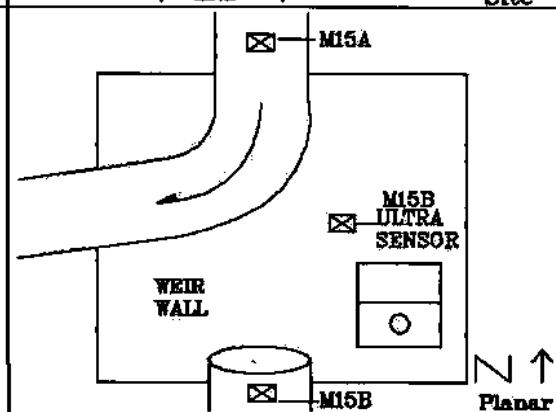
INSTALLATION			
SPECIAL INSTALLATION: ULTRASONIC,			
VELOCITY & PRESSURE INSTALLED 6.0'			
U/S ON BRICK PIPE SURFACE			
SAFETY			
Manhole Depth: 9.0'			
Traffic: LOW			
Gas @ Investigation: NEGATIVE			
Manhole Condition: GOOD			
Frame: Regular/Irregular REGULAR			
Q.C. Inspector:			
Date:			
Comments:			
Pipe Type: BRICK			
BACKUP	Y	N	?
Trunk Reg			
Lift Sta.			
STP			
Other Input			
Ind U/S			
L/S U/S			
Approval:			
Access Pole#:			
Distance from M/E:			
Road Cut Length: N/A			
Trench Length: N/A			
R.O.W. #: N/A			
GOOD 1500 MONITORING SITE			
INSTALL U/S ON BRICK SURFACE, NOT			
ON CONCRETE BEFORE CHAMBER			
HEAVY SQUARE M/H COVER FOR ACCESS			
Ind System Character: Residential/Commercial/Industrial/Vacant RESIDENTIAL/COMMERCIAL			
SAME CHAMBER AS M15B

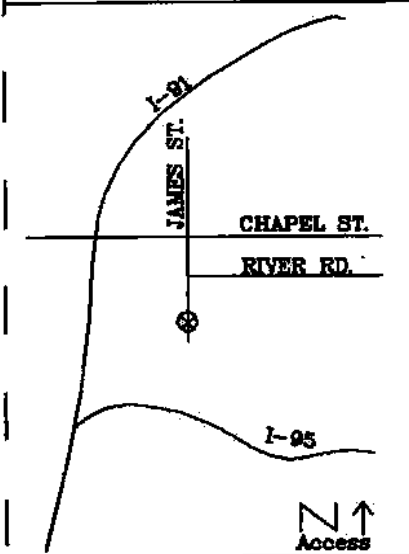
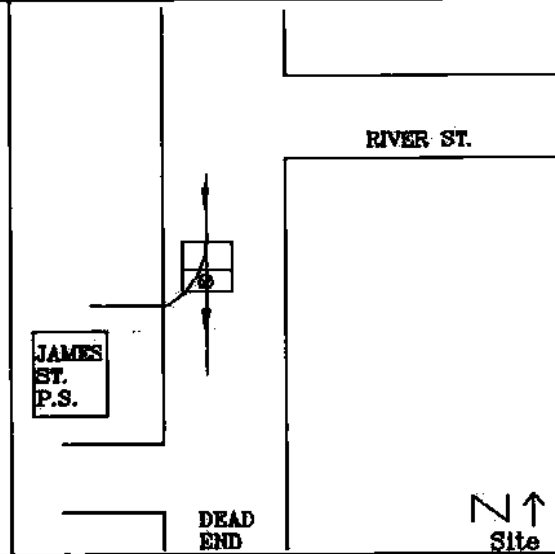
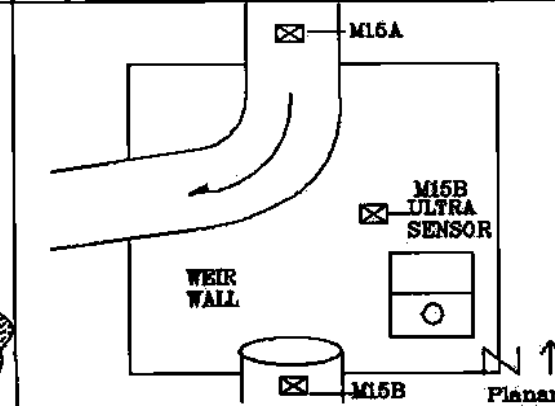
INSTALLATION				
SPECIAL INSTALLATION; VELOCITY & PRESSURE D/S IN WET WEATHER				
OVERFLOW LINE & ULTRASONIC				
INSTALLED OVER WEIR WALL				
SAFETY				
Manhole Depth: 9.0'				
Traffic: LOW				
Gas @ Investigation: NEGATIVE				
Manhole Condition: GOOD				
Frame: Regular/Irregular REGULAR				
Q.C. Inspector:				
Date:				
Comments:				
Pipe Type: CONCRETE				
BACKUP	Y	N	?	Distance
Trunk Reg				
Lift Sta.				
STP				
Other Input				
Ind U/S				
L/S U/S

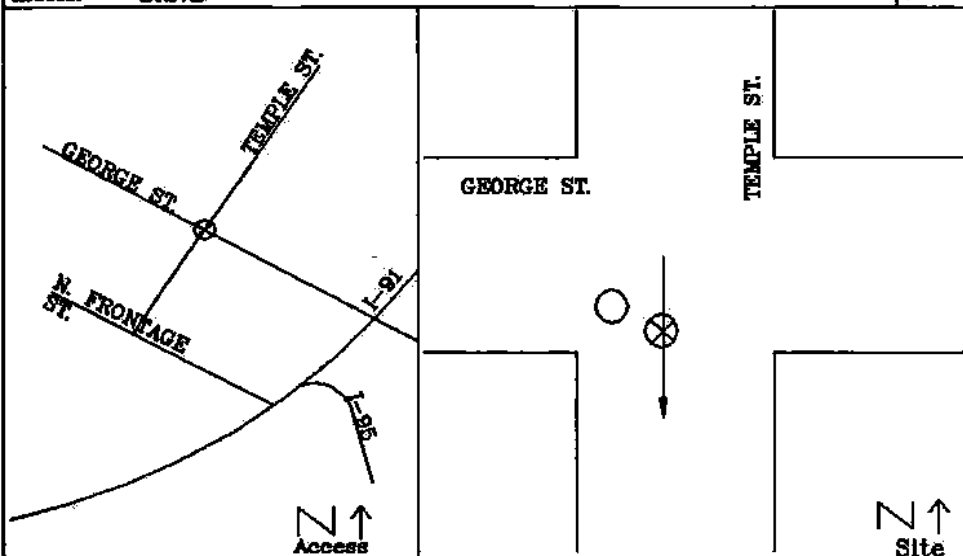
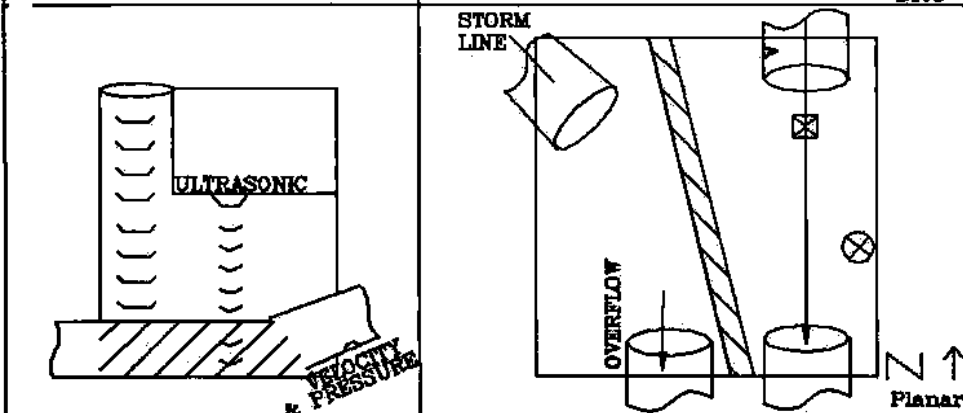
INSTALLATION	
48.00" RING WITH VELOCITY	
& PRESSURE INSTALLED AS FAR U/S	
AS POSSIBLE; ULTRASONIC INSTALLED	
ON CHAMBER OVERHEAD	
SAFETY	
Manhole Depth: 11.0'	
Traffic: HEAVY	
Gas @ Investigation: NEGATIVE	
Manhole Condition: FAIR	
Frame: Regular/Irregular REGULAR	
Q.C. Inspector:	
Date:	
Comments:	
Pipe Type: CONCRETE	
BACKUP	Y N ? Distance
Trunk Reg	
Lift Sta.	
STP	
Other input	
Ind U/S	
L/S U/S
